Project Report

Winery Ramón Bilbao, La Rioja

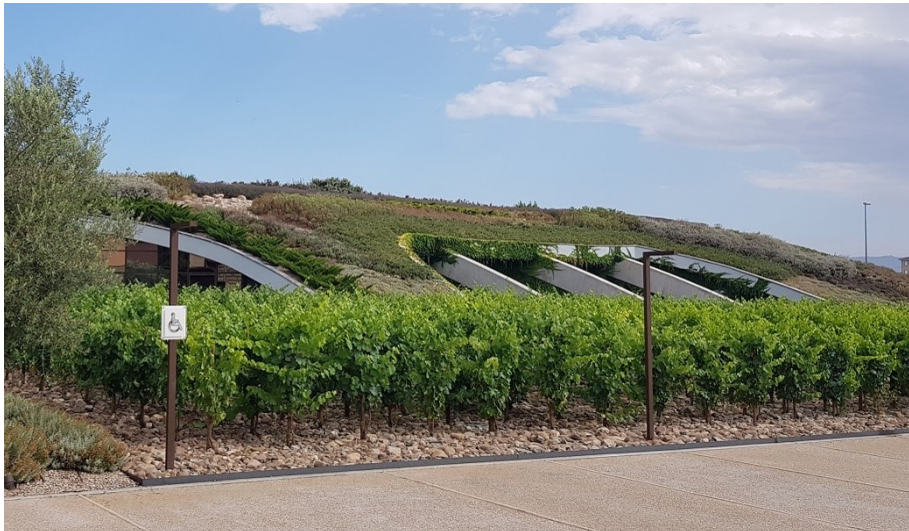
The green roof and the vines in front of the building have developed wonderfully in the 3 years since they were planted, creating a unique and inviting ambience.

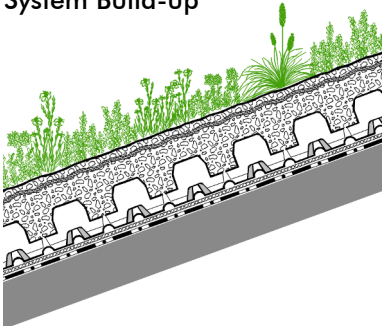
System Build-up

Vegetation layer
System Substrate
Floraset[®] FS 75
Protection Mat BSM 64
Roof construction with root resistant waterproofing

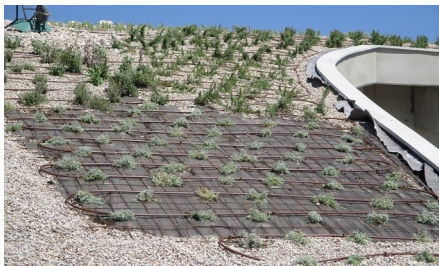
Good irrigation is important during the vulnerable growth phase after the initial planting in 2017. In steeper roof areas, the driplines are attached to separate lattices.

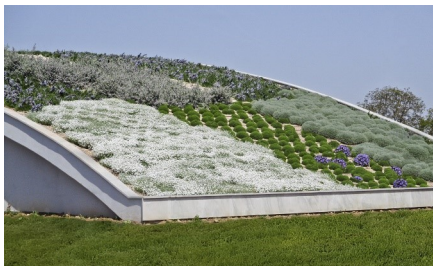
Just one year later, the plants are well established and have developed into a dense carpet of plants.

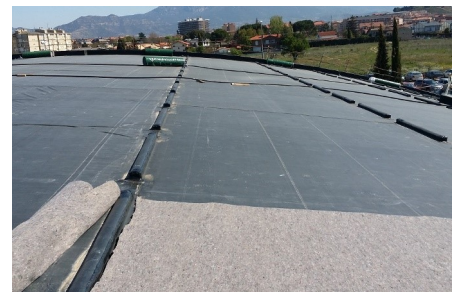
Stable shear barriers were concreted onto the roof and sealed in order to transfer the shear forces into the roof structure. The Protection Mat BSM 64 was laid on top of the root resistant waterproofing

therefore planted with typical vineyard vegetation and the numerous vines in front of the building leave no doubt as to where you are. Due to the barrel shape of the roof, the tried and tested pitched roof systems with FS 75 in the less steep areas and Georaster[®] in the steepest areas of the roof were used for the greening. This prevents the sub-strate from slipping. The considerable shear forces due to the size of the pitched roof are safely transferred into the roof structure by concrete shear barriers.

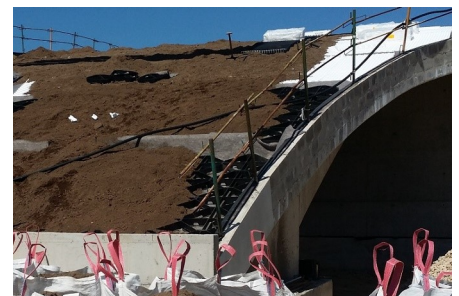
Floraset[®] FS 75 and Georaster[®] elements were installed in the the pitched and steep pitched

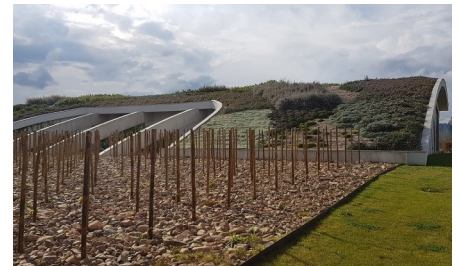
In 2018 the vines were planted in front of the building.
