PROJECT REPORT

WINERY RAMÓN BILBAO, LA RIOJA

System build-ups:
“Pitched Green Roof” with Floraset® FS 75 and “Steep Pitched Green Roof” with Georaster®

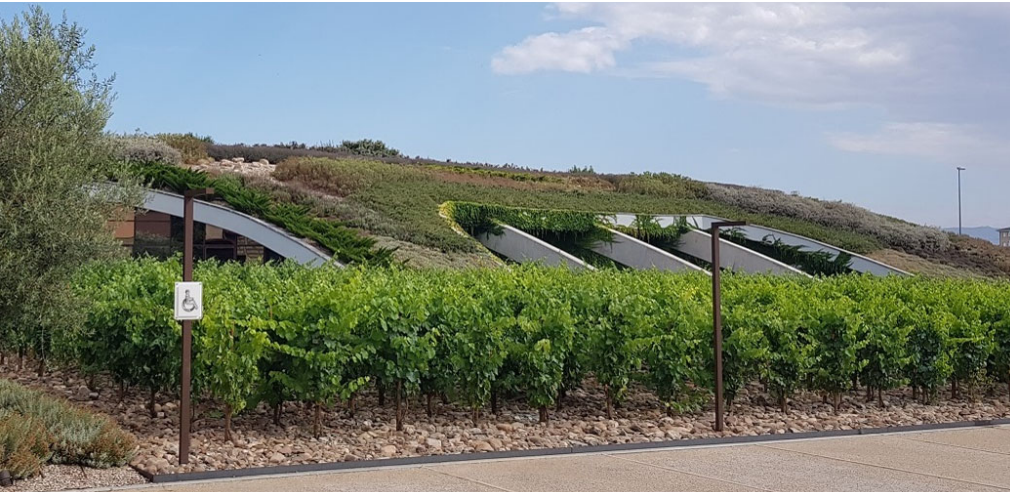
The green roof and the vines in front of the building have developed wonderfully in the 3 years since they were planted, creating a unique and inviting ambience.

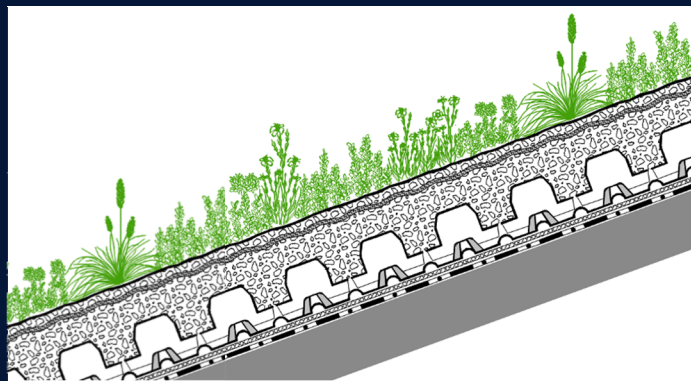
SYSTEM BUILD-UP

Vegetation layer

System Substrate

Floraset® FS 75

Protection Mat BSM 64

Roof construction with root resistant waterproofing

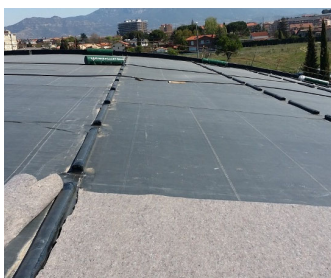
Stable shear barriers were concreted onto the roof and sealed in order to transfer the shear forces into the roof structure. The Protection Mat BSM 64 was laid on top of the root resistant waterproofing

vineyard vegetation and the numerous vines in front of the building leave no doubt as to where you are. Due to the barrel shape of the roof, the tried and tested pitched roof systems with FS 75 in the less steep areas and Georaster® in the steepest areas of the roof were used for the greening. This prevents the substrate from slipping. The considerable shear forces due to the size of the pitched roof are safely transferred into the roof structure by concrete shear barriers.

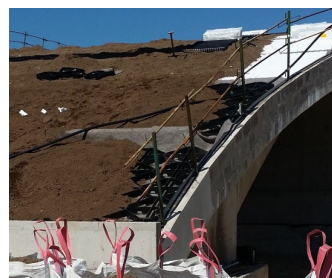
Floraset® FS 75 and Georaster® elements were installed in the pitched and steep pitched areas to prevent the substrate from sliding.

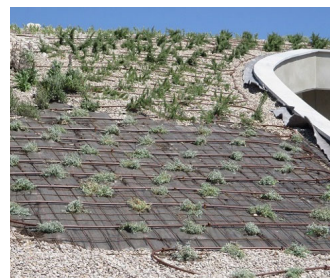
Good irrigation is important during the vulnerable growth phase after the initial planting in 2017. In steeper roof areas, the driplines are attached to separate lattices.
